Product Comparison Bulletin

5080-2103-9 NTRP Spindles with Welded Key

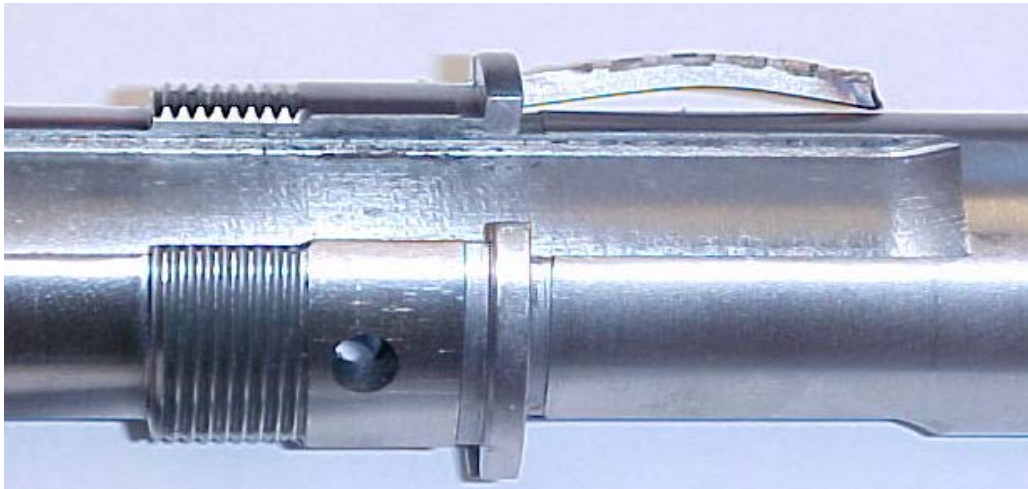
- Although the welds look good, looks can be deceiving.
- The key came out in our tear-out test, and failed the test.
- The same test was applied to a Davenport Staked Key and the Davenport Key stayed in the spindle, and passed the test.

- Based on this single destructive test, the welded key is more likely to break and come loose than a Davenport Staked Key.
- If the key shears or wears out, the collet is almost impossible to remove, because there is nothing to stop inner spindle rotation.

- **If the part were to stop turning, because the inner spindle no longer has a key, extensive tool damage and possible machine damage could occur. Cheap or inferior parts can save you pennies, but can cost you thousands.**

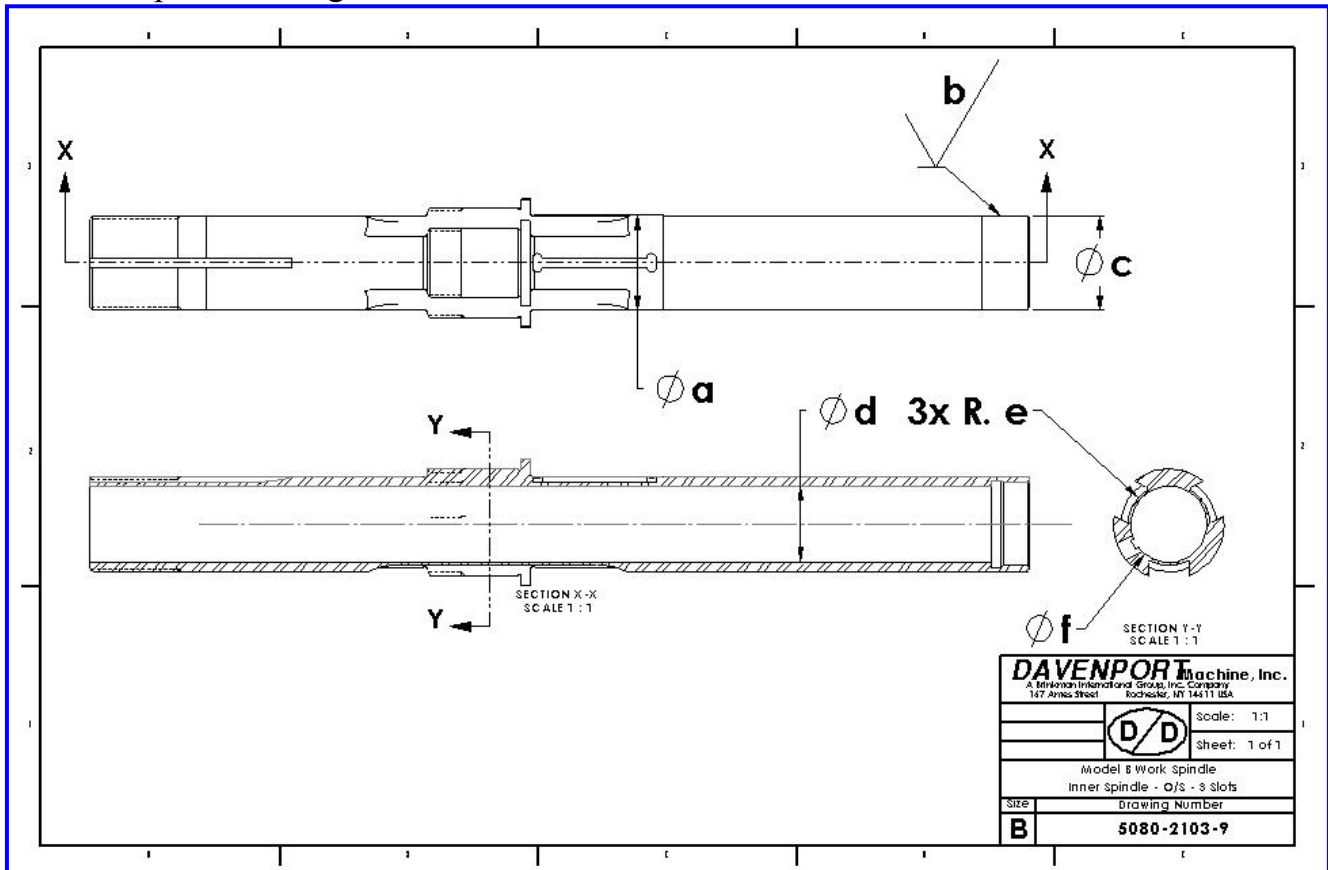
Davenport drawing 5080-2103-9

- The spindle was inspected for conformance to a Davenport drawing (next page). Of the 9 most important dimensions checked, 67% were outside of our acceptable range.

- Using the NTRP spindle would probably make machine setup to run good parts more difficult than it needs to be, most notably on mid to high precision parts.

- The spindle could prevent the machine from running tight tolerance parts consistently.

- a. Pilot \varnothing for rear of outer spindle – too low by .0020/.0025 – can cause part chatter, taper, and run out.
- b. Finish of pilot \varnothing for collet – up to 49RMS – finish is too rough, could cause collet to stick closed and wear early.
- c. Pilot \varnothing for collet – too small by .002/.003 – can cause run out and taper. This is the likely reason the collets are not sticking *every* time.
- d. Inner diameter – too big by .0007/.0015 – possible excessive vibration in feed tubes when running at high speeds, but not very significant.
- e. Slot depth for extensions – too shallow by .002 – could cause extensions to bind, preventing assembly and causing collets to stick shut.
- f. Ball bearing diameter – too small by .00015 – slightly looser location fit on spindle bearings. Will allow more run out/taper on a part than a Davenport Spindle.
