## Product Bulletin

### 5133-R REVOLVING HEAD GEAR - FIELD REPAIR

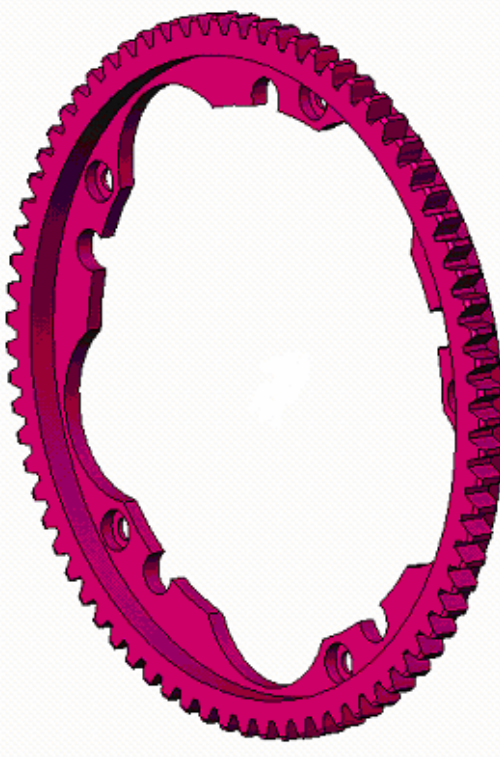
The standard procedure for repairing a damaged **5133 Revolving Head Gear** involves replacing that gear with a new **5133**, and then re-machining the counter-bored face of the gear, and the end face of the 8-SA revolving Head, to re-establish a flush mounting face for the Left End Bracket.

The **5133-R** is a “Field Repair” version of the *Revolving Head Gear*, and was developed for in-field repairmen who are unable to re-machine the counter-bored face of this gear due to the lack of large lathe equipment. It will sit flush, or slightly below the existing face of an unmodified, Davenport OEM **8-SA**. This allows repairmen the option to replace the gear, while still mounting the Left End Bracket square to the head axis. Davenport still recommends a properly fitted **5133** gear when possible, but the **5133-R** provides an acceptable alternative when the proper replacement procedure cannot be done.

- Pre-machined Counter-Bore
- Eliminates need for field machining
- Same, high-quality materials, heat treat, and gear form as OEM 5133
- 100% interchangeable with all genuine Davenport OEM Parts
